Tesla released the P85D in 2014. At that time the vehicle came with "insane mode" acceleration with a 0-60 time of 3.2 seconds. Later in July of 2015, Tesla announced "Ludicrous mode" that cut the 0-60 time down to 2.8 seconds. This upgrade was offered both new and as a hardware and firmware change to the existing fleet of P85D vehicles. Since then, Tesla has released newer ludicrous vehicles. What makes the P85D upgrade unique was how the process required changes to the vehicle's Battery Management System(BMS). The BMS handles power requests from the drive units and other components of the car. This paper will outline the ludicrous upgrade process through reverse engineering CAN bus messages, CAN bus UDS routines and various firmware files contained on the car.

Vehicle Overview

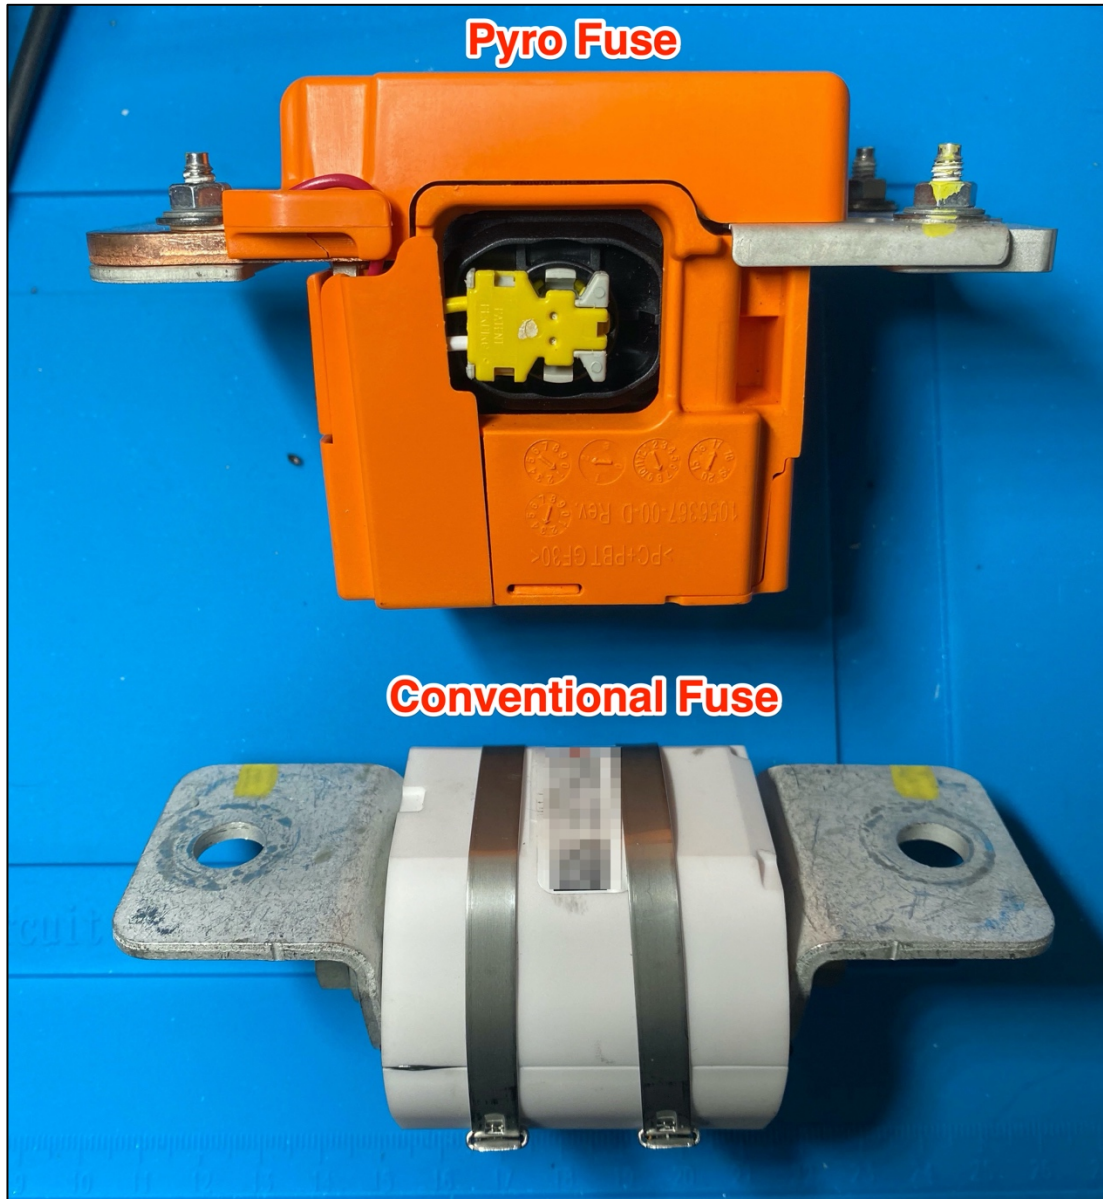
Figure 3: Tesla Fuses

The pyro fuse replaces a traditional melting fuse with one that can be triggered to fire a squib charge that separates two halves of the battery very quickly. Figure 3 shows the two different types of fuses. The conventional fuse is the actual one that came out of donor vehicle.

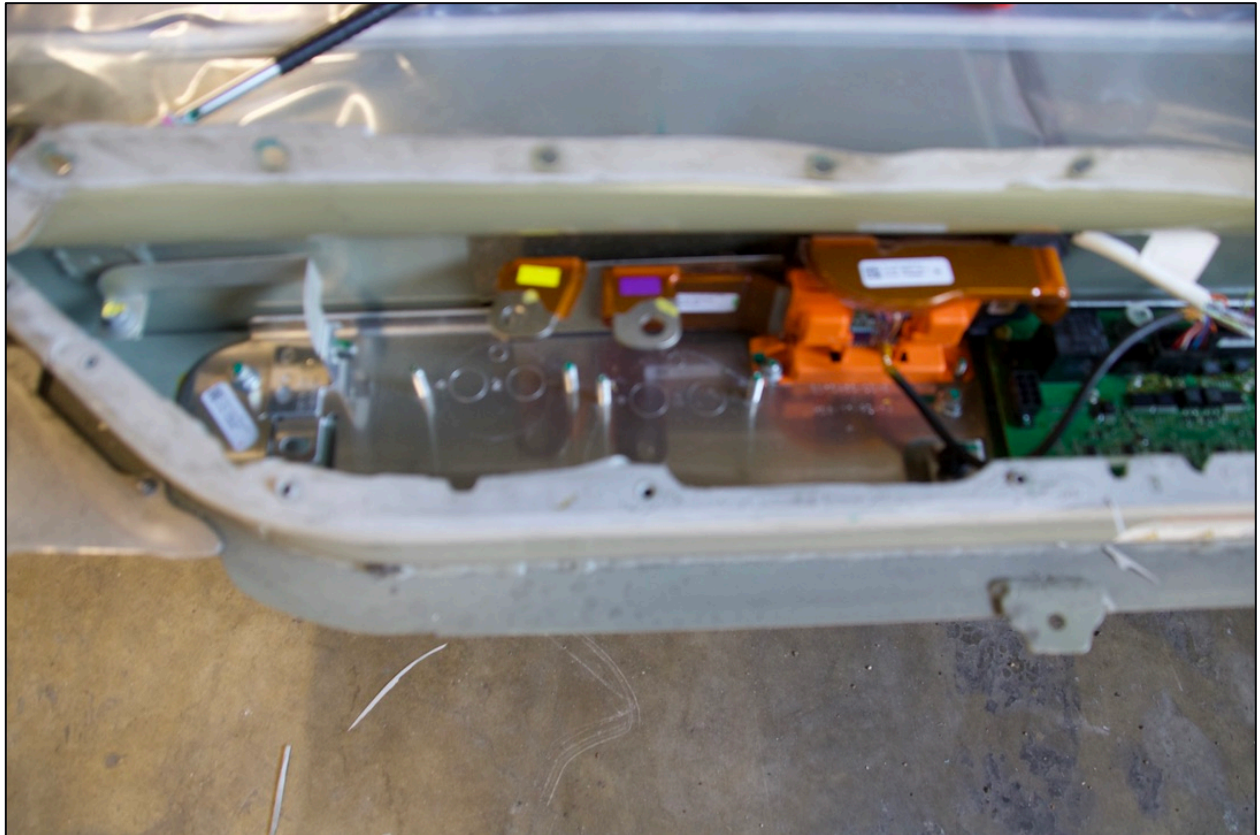
Figure 4: Contactor Bay

The battery's contactor bay contains the BMS, current shunt, and contactors. The two contactors each connect to the negative and positive sides of the battery. The BMS also has voltage sense lines that connect to each side of the contactors terminals, therefore the BMS can detect faults in the contactors that would indicate the contactor(s) are not in the state expected by the BMS. Figure 4 shows the contactor bay with the contactors removed:

The contactors are replaced with higher current capable units. The battery pack must be removed from the vehicle in order to replace these components as well as modify the current shunt.

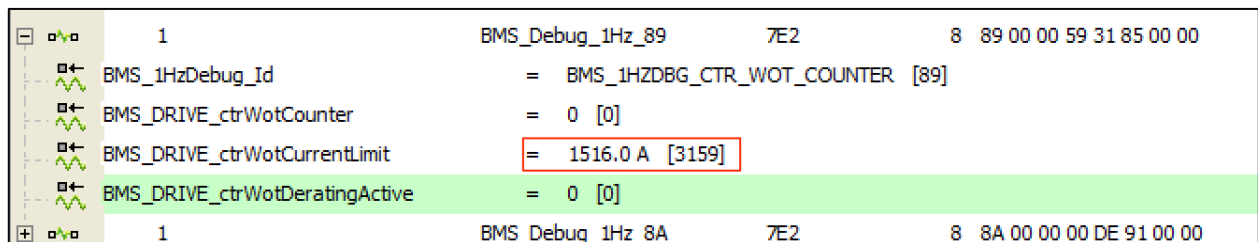
Figure 9: New Current Limits

After the upgrade the car indicated a higher current was available, as shown in Figure 9:

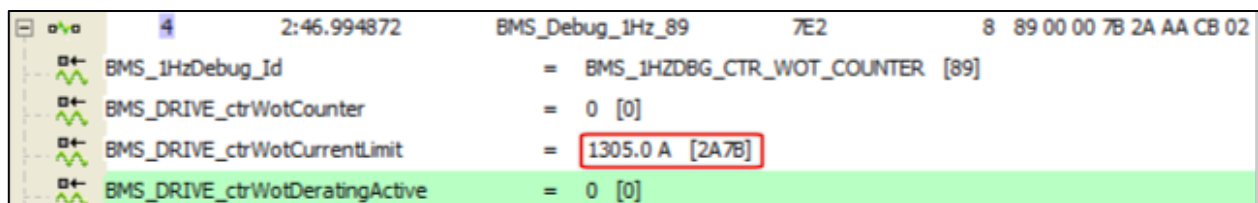
Figure 10: Pre-upgrade Current Limits

For reference the current limits prior to the upgrade are shown in Figure 10:

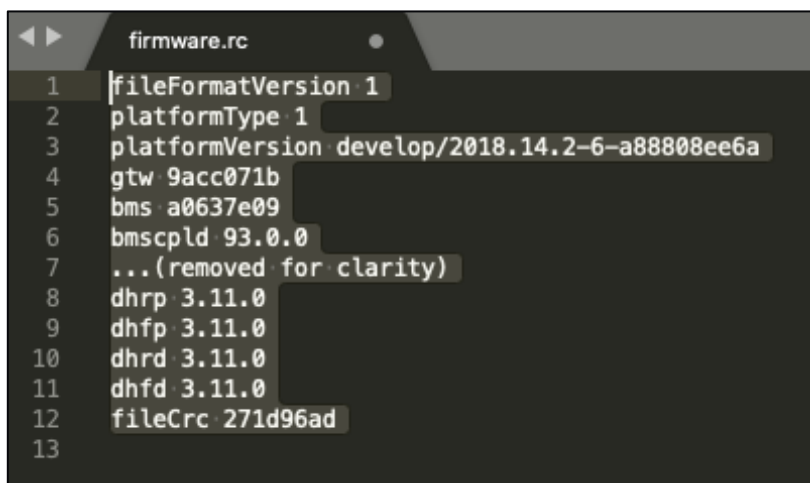
Figure 11: Section of firmware.rc

The Donor Car would not engage into drive and the gateway indicated a BMS mismatch, this error was expected as it was generated on the bench during testing. The error was supposed to clear with either a firmware redeploy or firmware upgrade, however both failed.

After analysis of the logs, an error regarding “firmware.rc” was seen. The only reference I could find to this file was in a previous security talk where the file was used by the security gateway. Similar to how the “internal.dat” configuration file was requested. This file was then downloaded from the security gateway and examined. A snippet is shown in Figure 11:

Note the 4-byte values for bms and filecrc. The value for the bms corresponded to a packid 57 firmware from the “version_map2.tsv” file and the file crc value was a crc32/jamcrc value of the entire file, minus the crc line. The firmware.rc file bms line was modified, the crc value recalculated and this file was uploaded to the gateway. Once the gateway was rebooted the errors cleared and the car could be put into drive and driven with the additional power from ludicrous.
