Tesla released the P85D in 2014. At that time the vehicle came with "insane mode" acceleration with a 0-60 time of 3.2 seconds. Later in July of 2015, Tesla announced "Ludicrous mode" that cut the 0-60 time down to 2.8 seconds. This upgrade was offered both new and as a hardware and firmware change to the existing fleet of P85D vehicles. Since then, Tesla has released newer ludicrous vehicles. What makes the P85D upgrade unique was how the process required changes to the vehicle's Battery Management System(BMS). The BMS handles power requests from the drive units and other components of the car. This paper will outline the ludicrous upgrade process through reverse engineering CAN bus messages, CAN bus UDS routines and various firmware files contained on the car.

Vehicle Overview

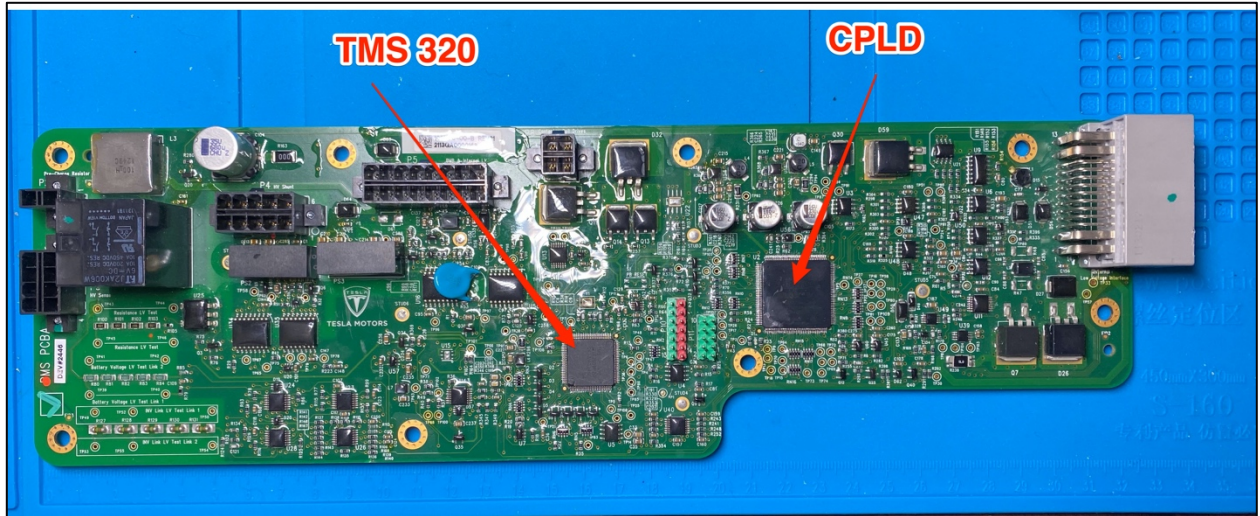
Figure 1: BMS Overview

The BMS is the deciding module that allows the drive units to have only as much power as the BMS allows. It is contained on a circuit board inside the battery pack, it can only be physically accessed by removing the battery from the vehicle. Figure 1 shows a BMS purchased on the secondary market for this research:

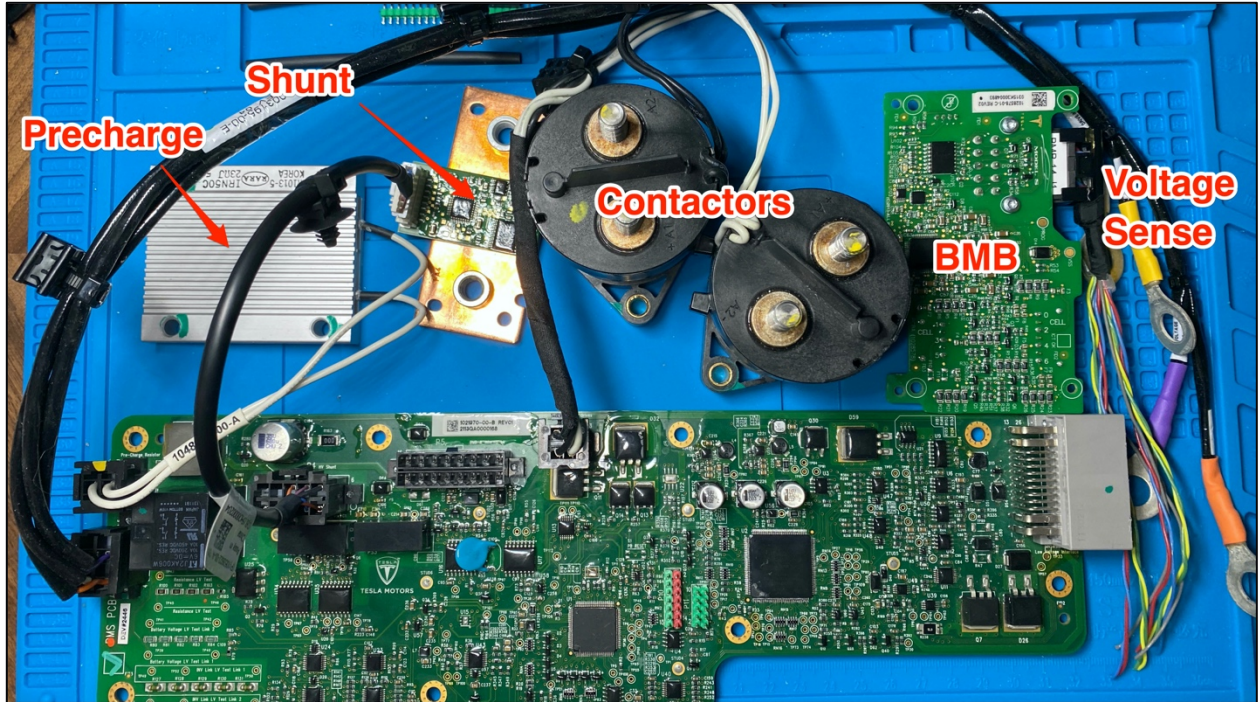
Figure 2: BMS Components

Figure 2 shows all of these components as well as the high voltage sense wires that connect to each side of the contactors:

A conversation with a former Tesla tech confirmed a wire needed to be cut on the shunt during the upgrade process. Further analysis indicated the shunt wire that was disconnected in fact connected to the CPLD, as this device was a hardware backup to the TMS320 it made sense that the CPLD would need a way to detect an overcurrent condition.
