AUGUST 5-6, 2020 Briefings

Reverse Engineering the Tesla Battery Management System to Increase Power Available

By Patrick Kiley

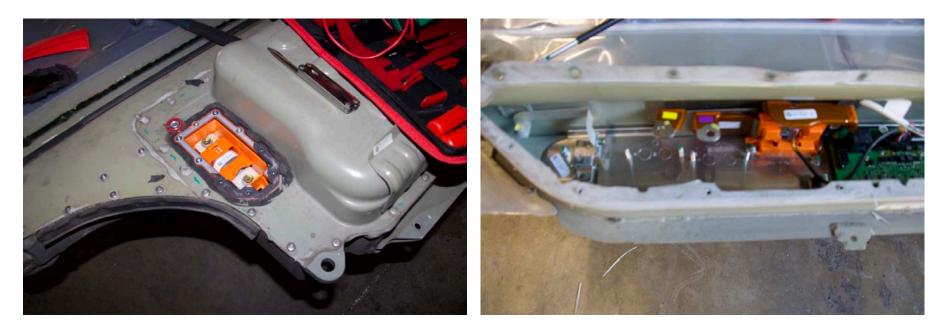
Fuse and Contactor Bay

- P85D announced on Oct 10, 2014
- Ludicrous announced on July 17, 2015
- 10K for new buyers, 5K for existing P85D owners
- Upgrade involved new contactors and pyro fuse.
- Many performance battery packs would come standard with new components
- They were "ludicrous capable"
- All 100kWh performance battery packs are "ludicrous capable"
- Ludicrous capable means add "performanceaddon 1" to internal.dat on the gateway

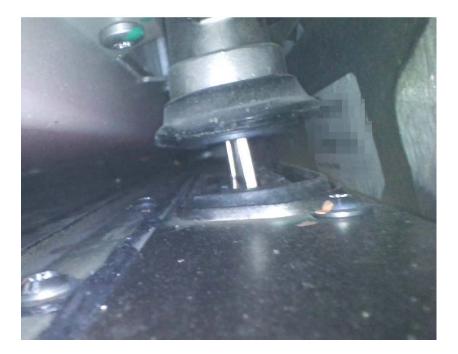
Upgrade Process

- Had access to garage and lift in Southern California
- Drove there to do upgrade, arrive with low SOC
- Drop pack, do hardware stuff
- Reinstall pack, carefully (image is from borescope)
- Flash BMS with special firmware for shunt modification
- Flash BMS to new packID
- Update internal.dat to add ludicrous and change packID
- Redeploy firmware due to changed battery packID
- Drive away and enjoy the ridiculous amount of torque?
